# INDIANA DEPARTMENT OF ENVIRONMENTAL MANAGEMENT

January 22, 1997

Re: Gary Development Company Landfill  
RCRA Docket No. RCRA-V-W-86-R-45  
EPA I.D. No. IND 077 005 916

On November 19, 1996, a visit to the above-captioned site was made by myself and Mr. Kirk Maravolo of the Indiana Department of Environmental Management, representatives of U.S. EPA Region V, and Mr. Steve Cherry and Ms. Lisa McKinney from Bose, McKinney & Evans. Enclosed, as previously requested, are two (2) additional photographs that were obtained by Mr. Maravolo during this visit.

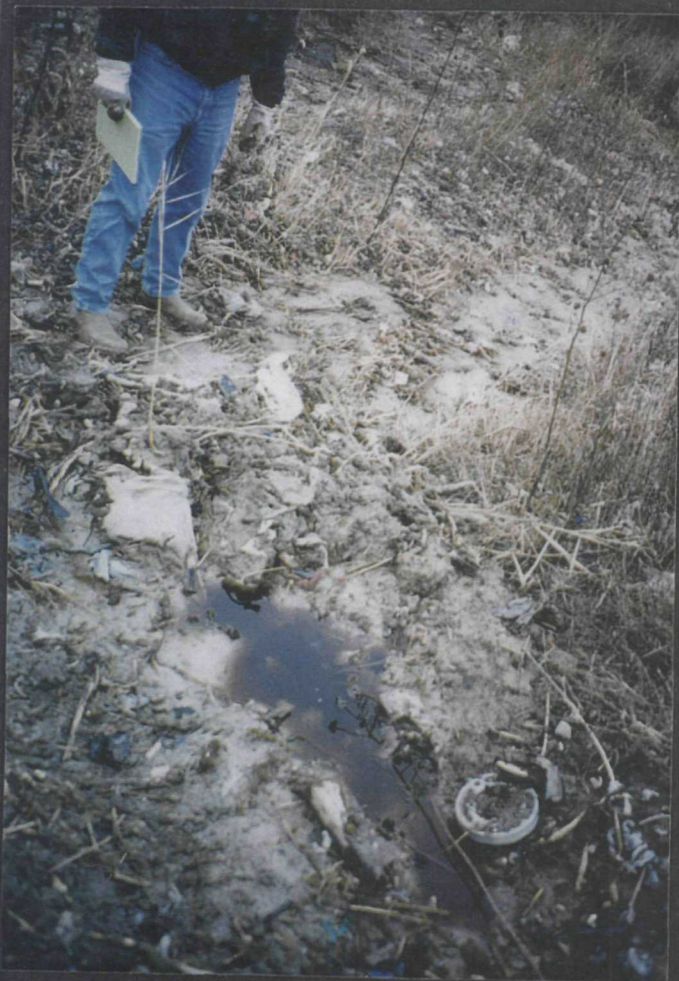
11-19-96 KIRK MARAVOLO, IDEM  
 GARY DEVELOPMENT LANDFILL  
 #1 - LEACHATE OUTBREAK AT  
 NORTH FACE OF LANDFILL. (BLACK  
 COLOR, FOUL ODOOR.) ✓

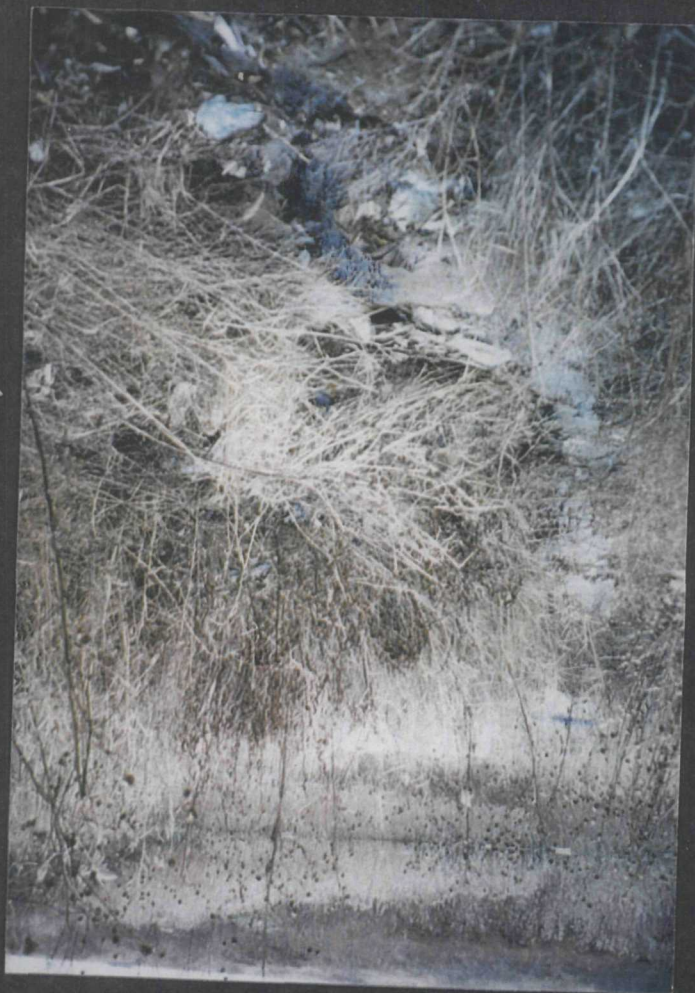
11-19-96 KIRK MARAVOLO, IDEM P  
 GARY DEVELOPMENT LANDFILL  
 #2 - FLOW OF LEACHATE TOWARDS  
 STORMWATER / LEACHATE POND FROM  
 OUTBREAK ON N. FACE OF LANDFILL

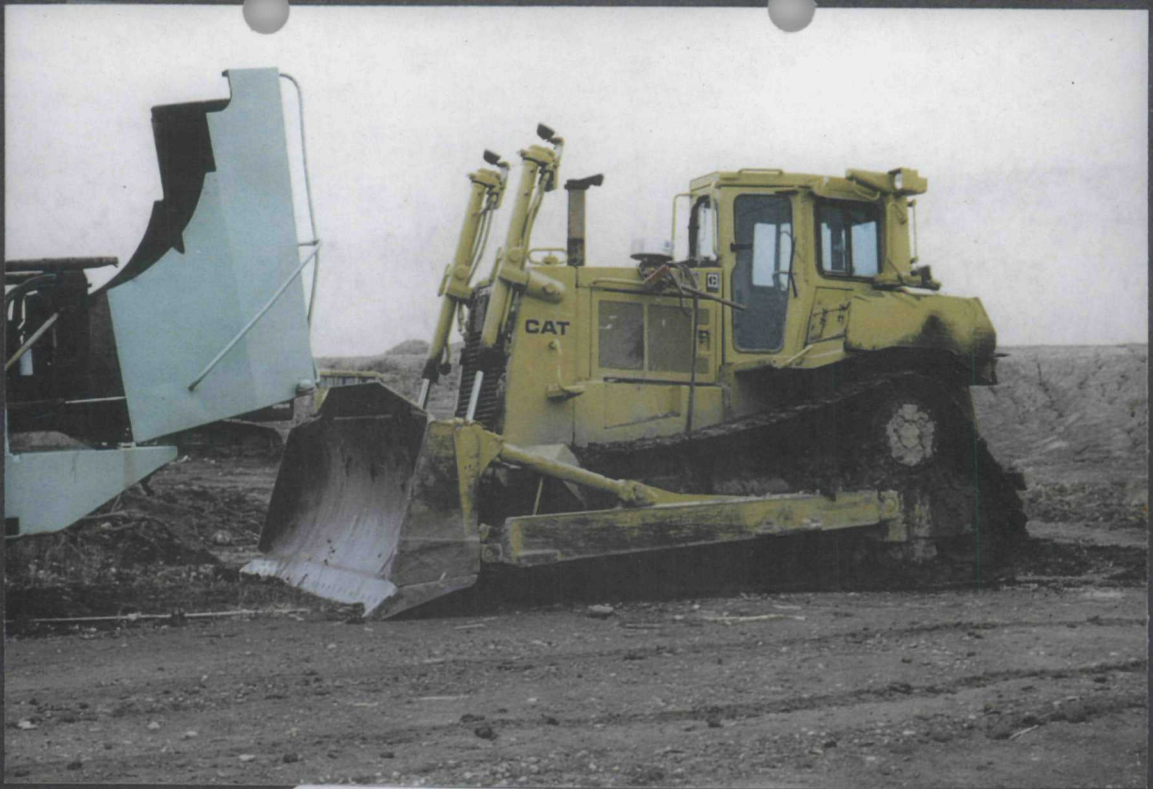
11-19-96 M. Mikulka  
Gary Development Landfill  
#1 -- Existing bulldozer at site

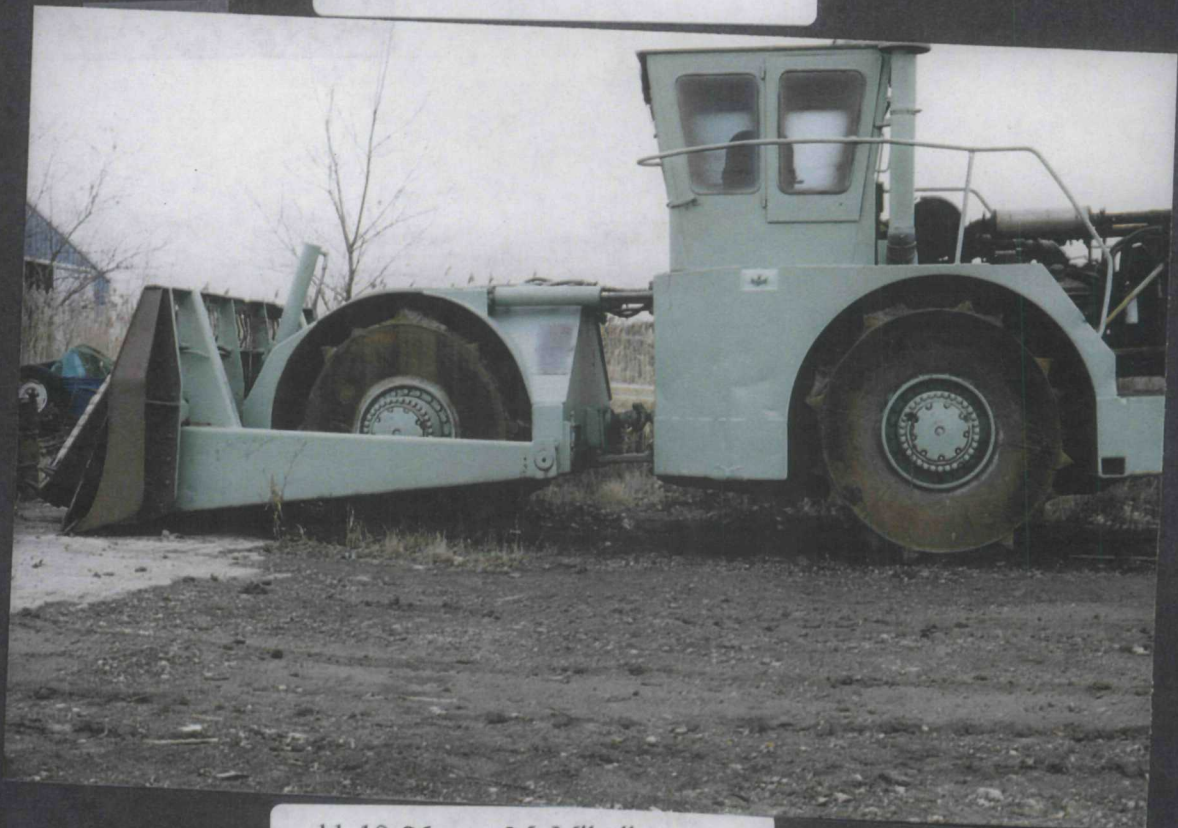
11-19-96 M. Mikulka  
Gary Development Landfill  
#2 -- Existing compactor at site

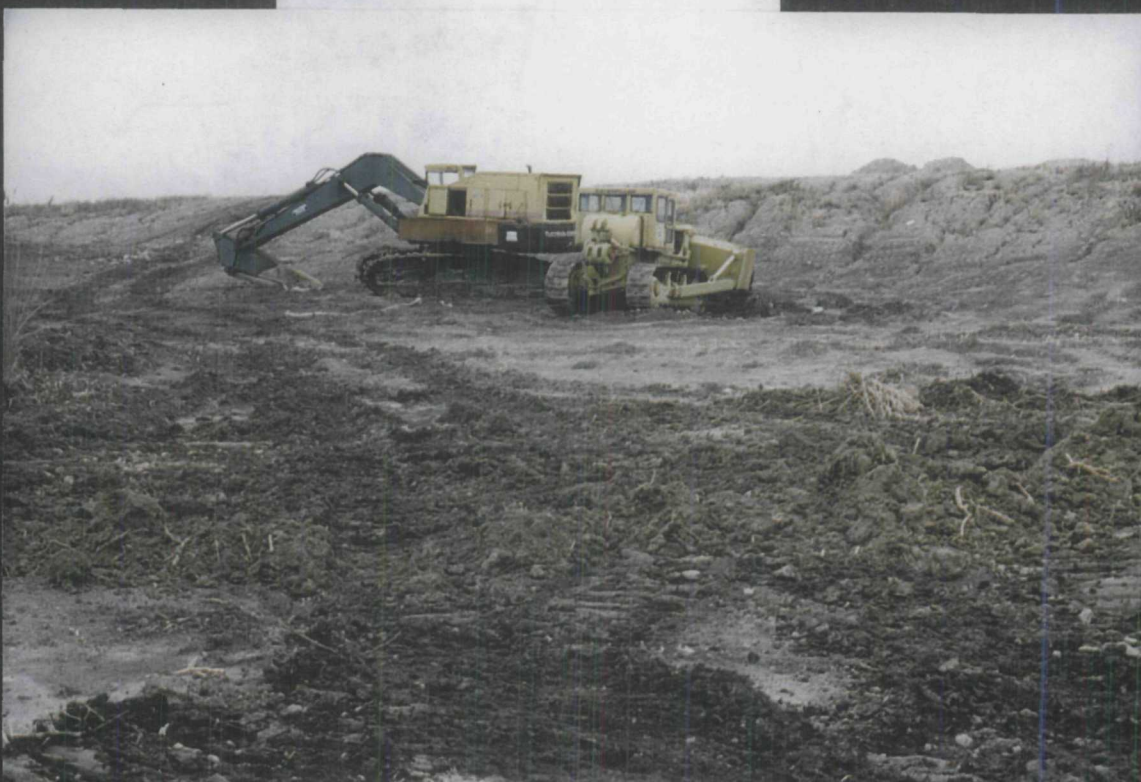
11-19-96 M. Mikulka  
 Gary Development Landfill  
 #4 -- Heavy equipment at site  
 location proposed for storm water  
 management basin. Note heavy  
 erosion of site slopes in  
 background.

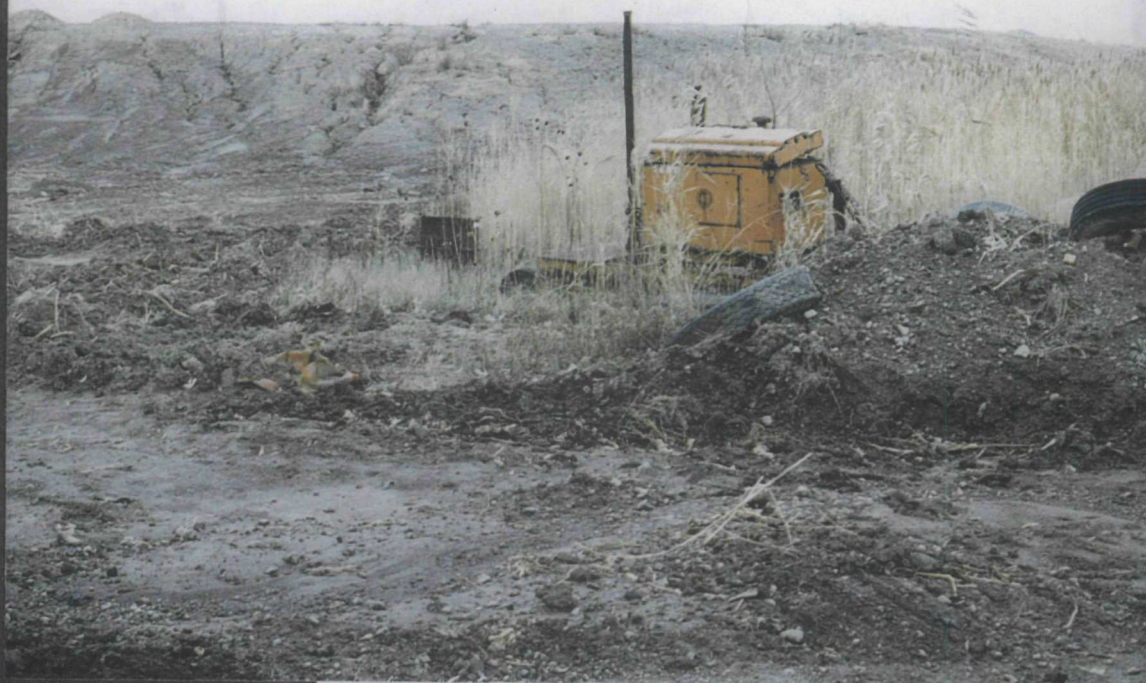
11-19-96 M. Mikulka  
Gary Development Landfill  
#5 -- solid waste (dirt and tires)  
dumped at site. Old equipment  
apparently abandoned. Note site  
erosion.

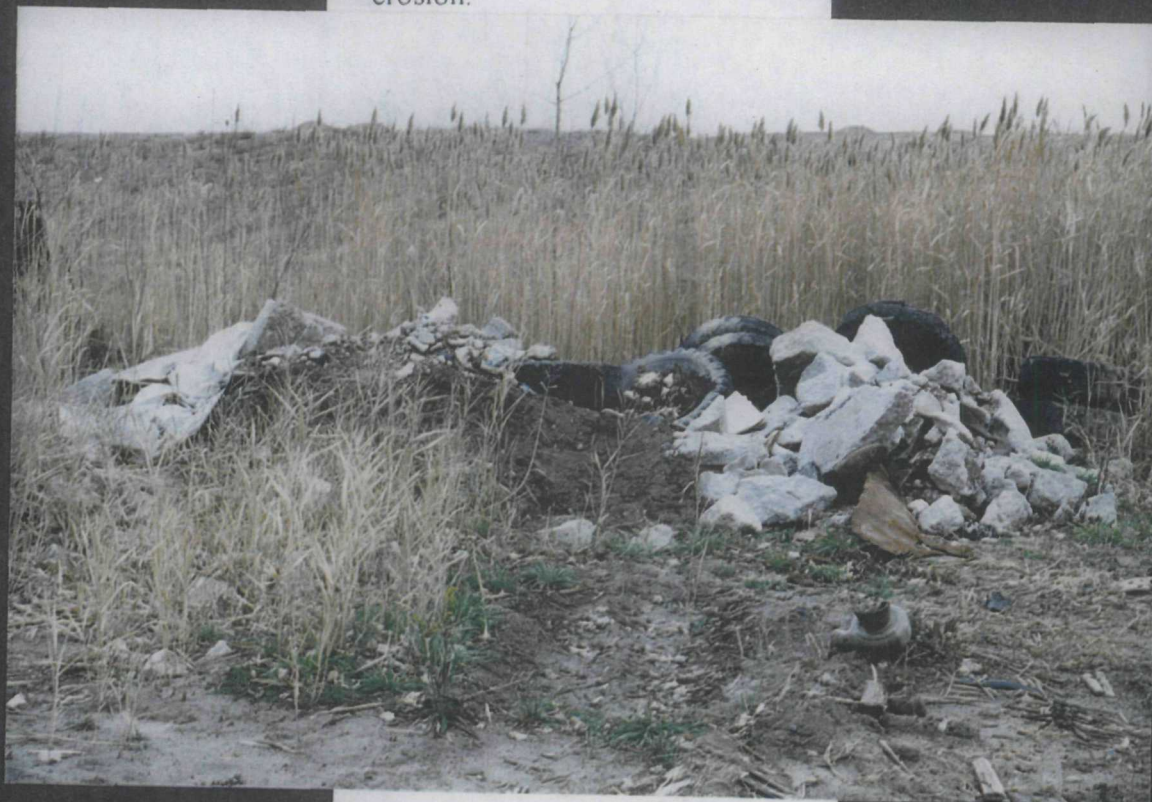
11-19-96 M. Mikulka  
Gary Development Landfill  
#6 -- Concrete rubble and tires  
dumped along road at site.

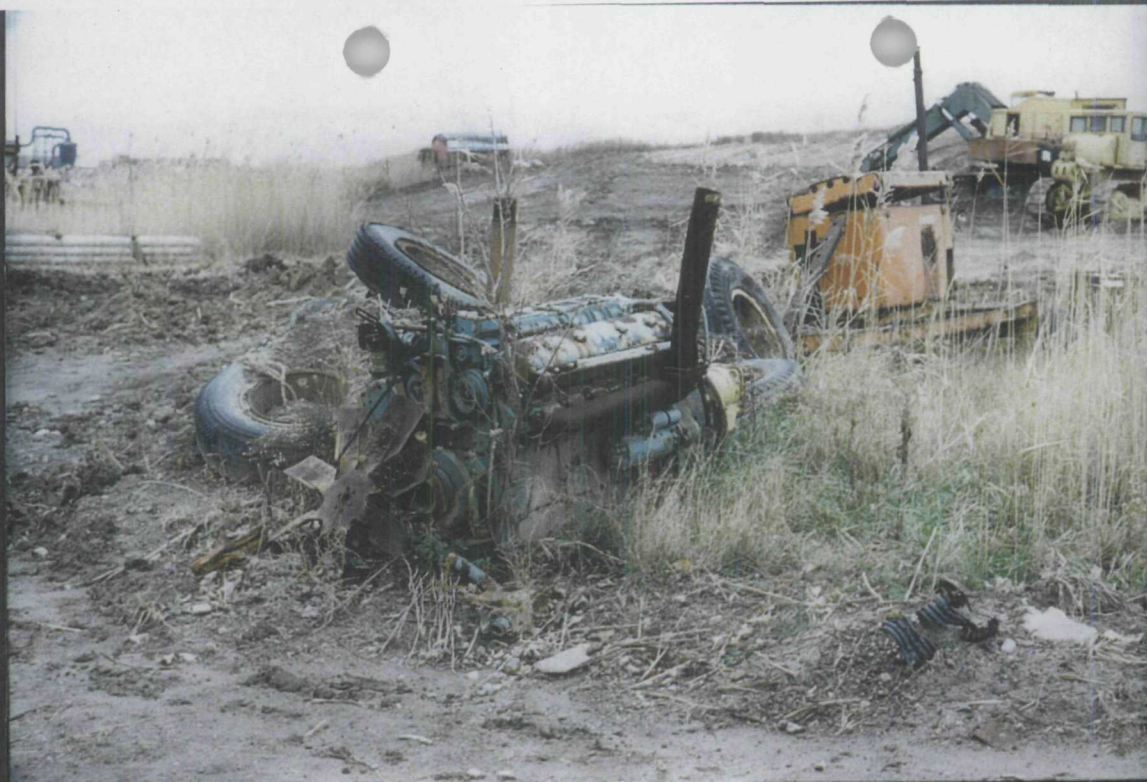
11-19-96 M. Mikulka  
 Gary Development Landfill  
 #7 -- old engine and tires at site.  
 View from road on S side towards  
 NW.

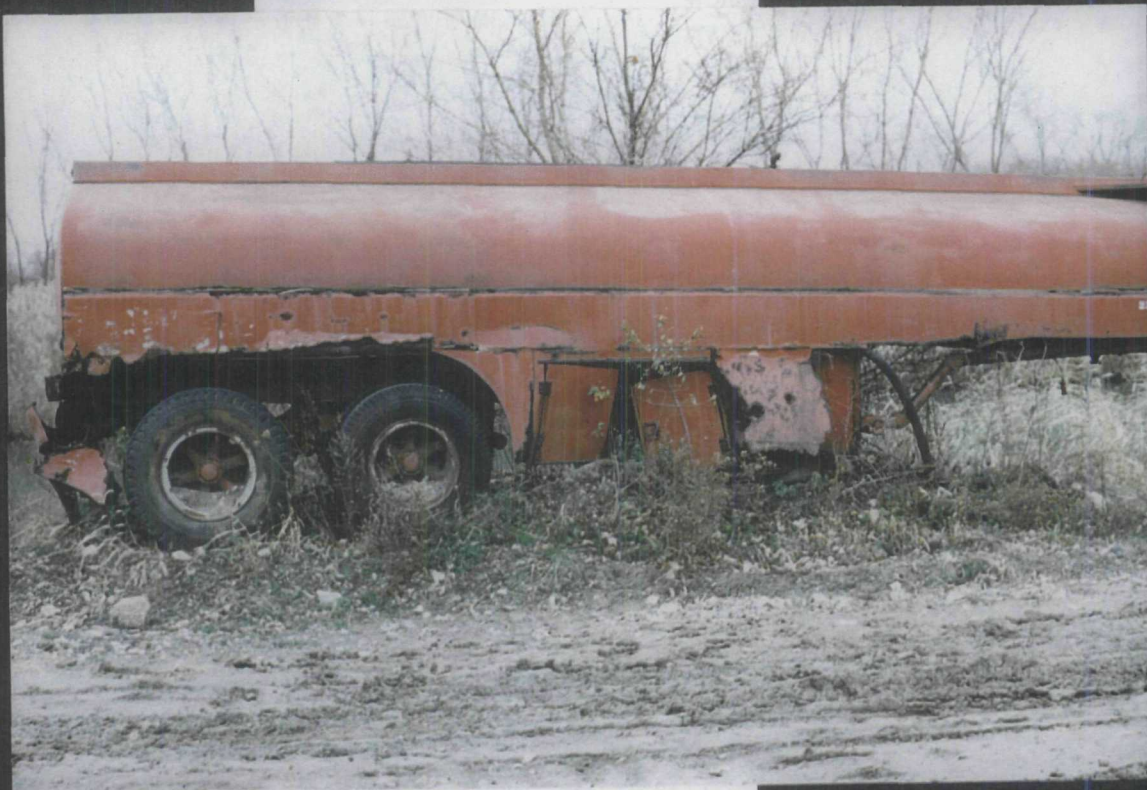
11-19-96 M. Mikulka  
 Gary Development Landfill  
 #8 -- Trailer abandoned at site on  
 S side of road. River behind.

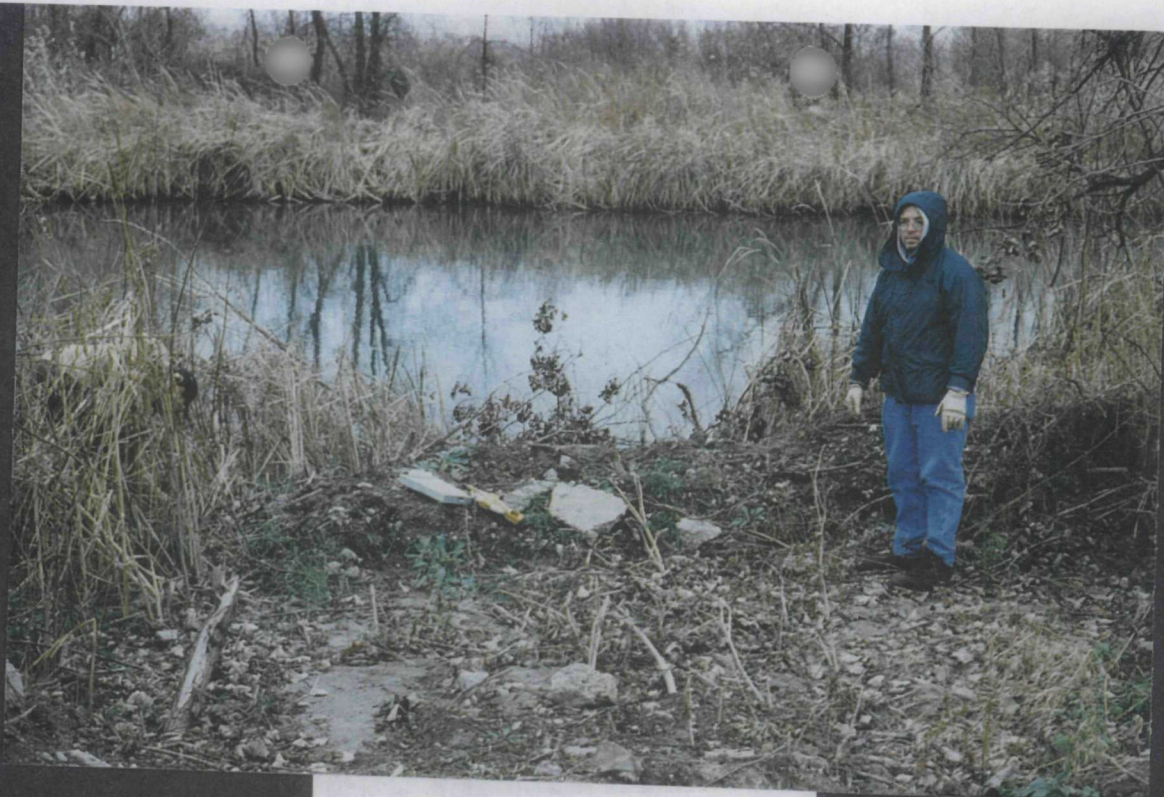
11-19-96 M. Mikulka  
 Gary Development Landfill  
 #9 -- Concrete and dirt dumped  
 near Grand Calumet River at site.  
 Kurt Maravolo, IDEM inspector  
 adjacent.

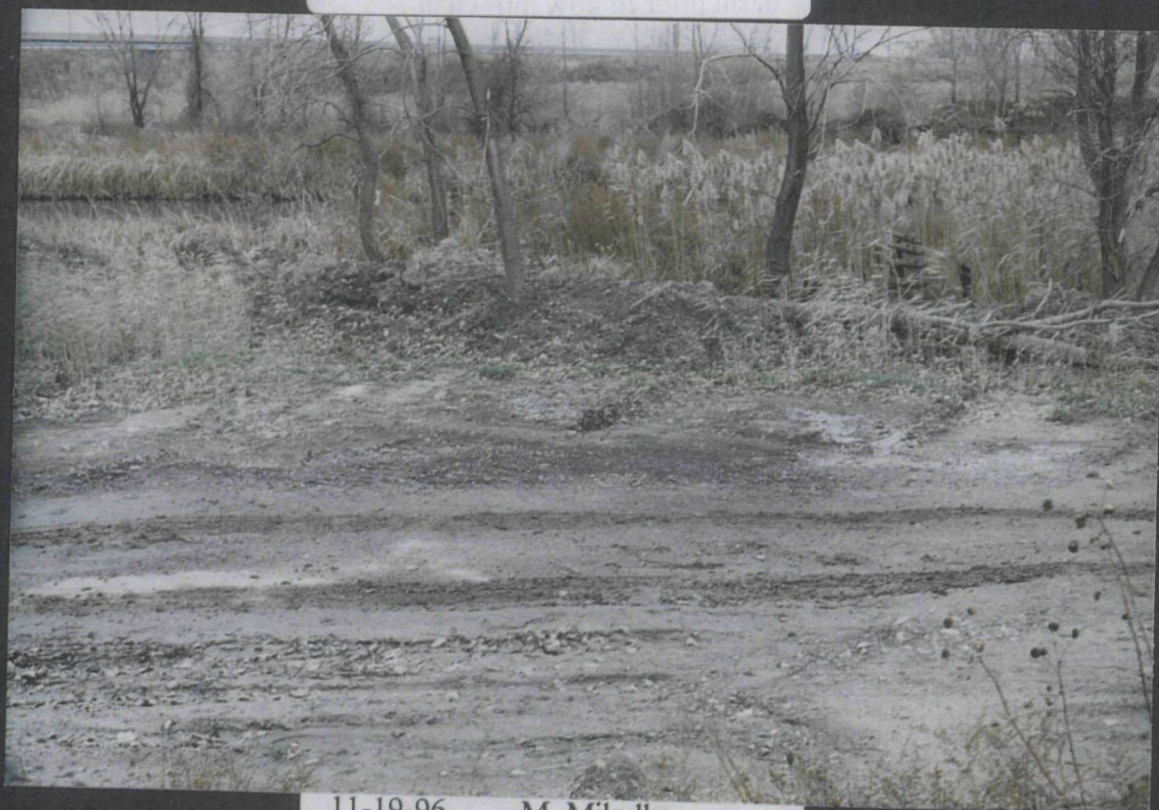
11-19-96 M. Mikulka  
 Gary Development Landfill  
 #10 -- Material pushed into  
 wooded wetland area at site.  
 View from road at GDC towards  
 Grand Calumet River.

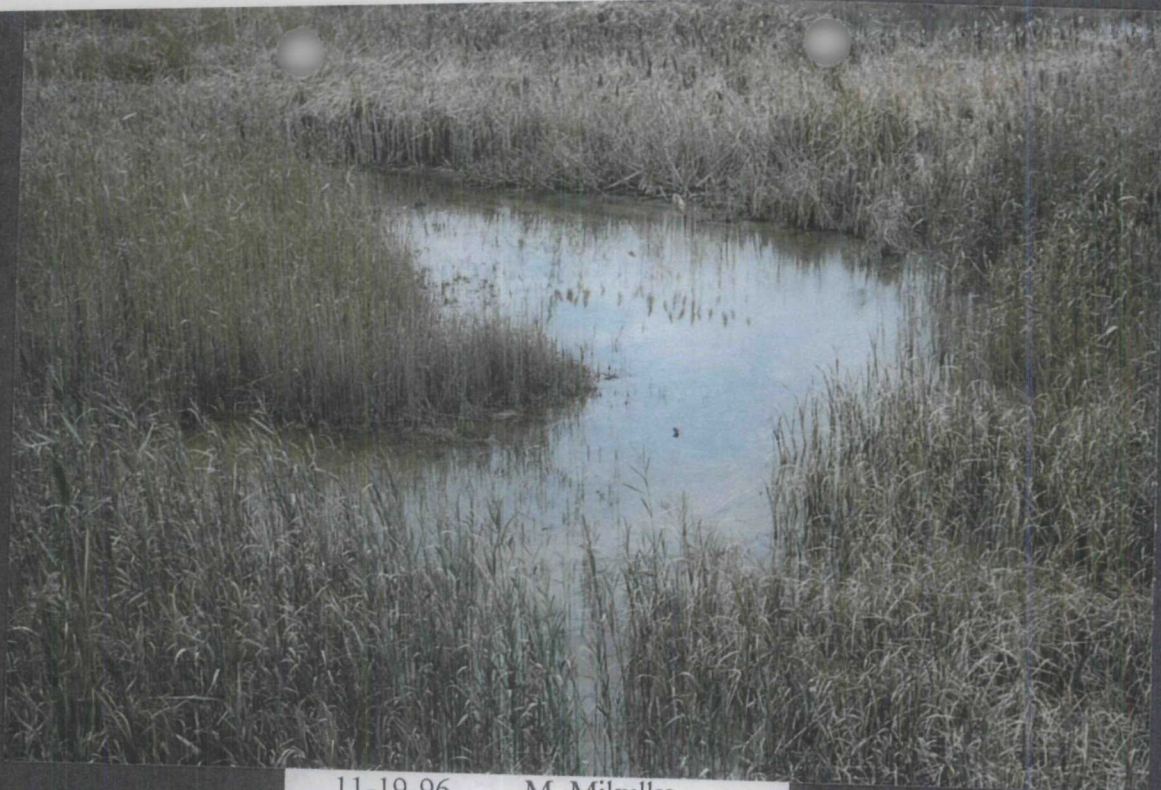
11-19-96 M. Mikulka  
Gary Development Landfill  
#11 -- View of ponded area on S  
side of road at site, at point where  
road elevates to top of landfill.  
Ponded area acts a sedimentation  
basin prior to flow into GCR.

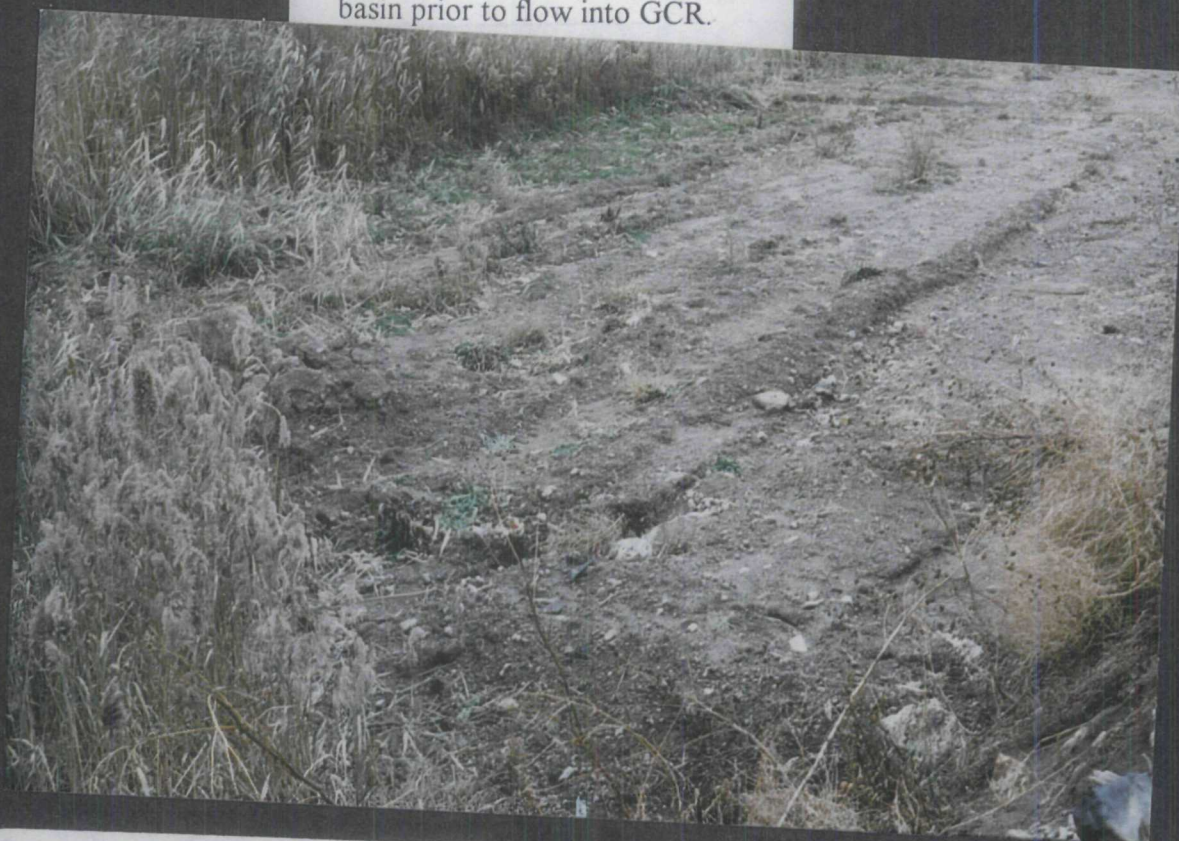
11-19-96 M. Mikulka  
Gary Development Landfill  
#12 -- View of area graded from  
road at site into ponded area seen  
in photo #11. Berm, which has

been breached, not visible in  
photo. Runoff from road drains  
down this slope.

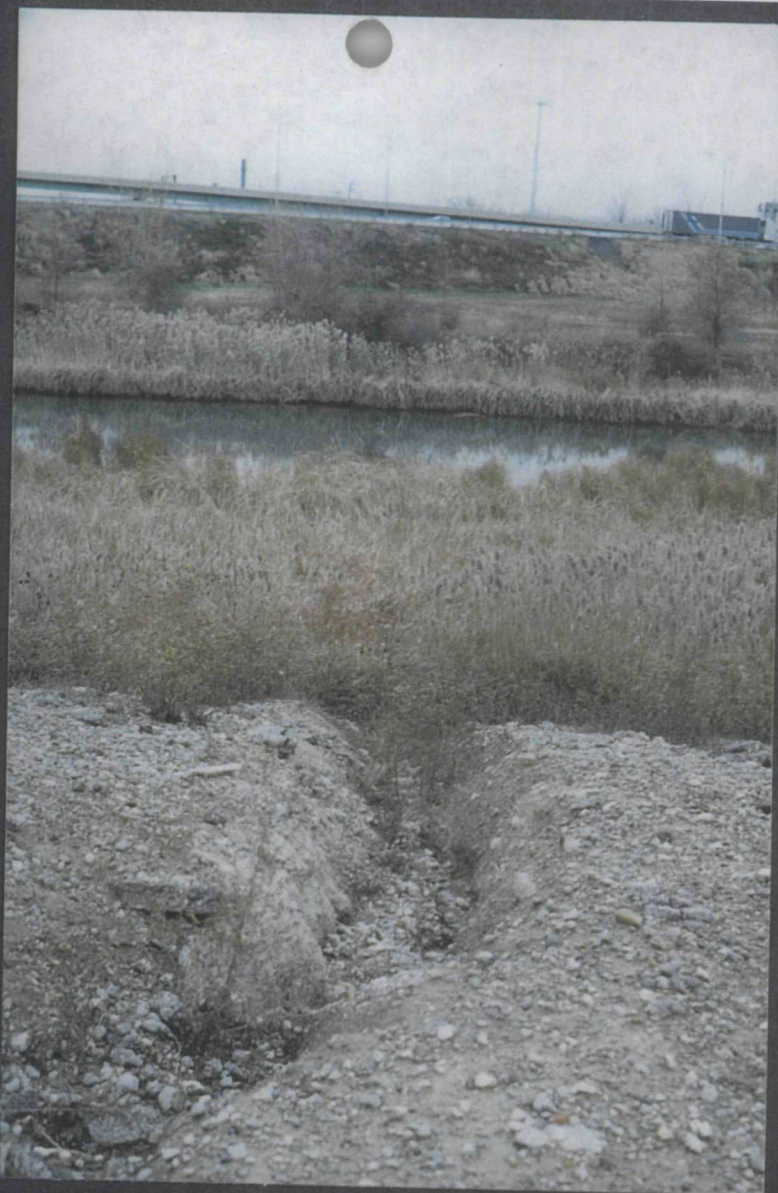
11-19-96 M. Mikulka  
 Gary Development Landfill  
 #13 -- Deep ravine caused by  
 surface runoff; estimated depth,  
 2'. Runoff drains towards  
 wetlands area @ SE side of  
 landfill. GCR in background.

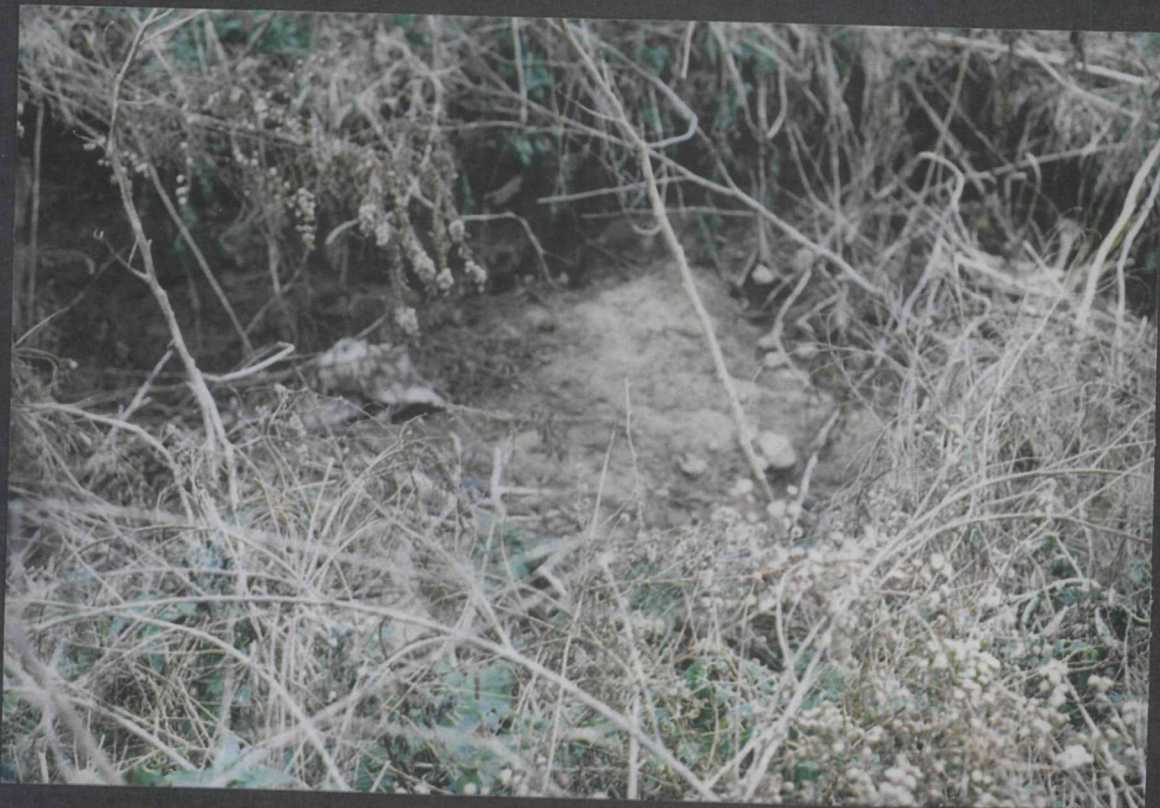
11-19-96 M. Mikulka  
 Gary Development Landfill  
 #14 -- View of ditch on E. Side of  
 Property. Heavily eroded, but  
 overgrown. Ditch conveys runoff  
 from E. Side of Property to  
 wetlands area/GCR.

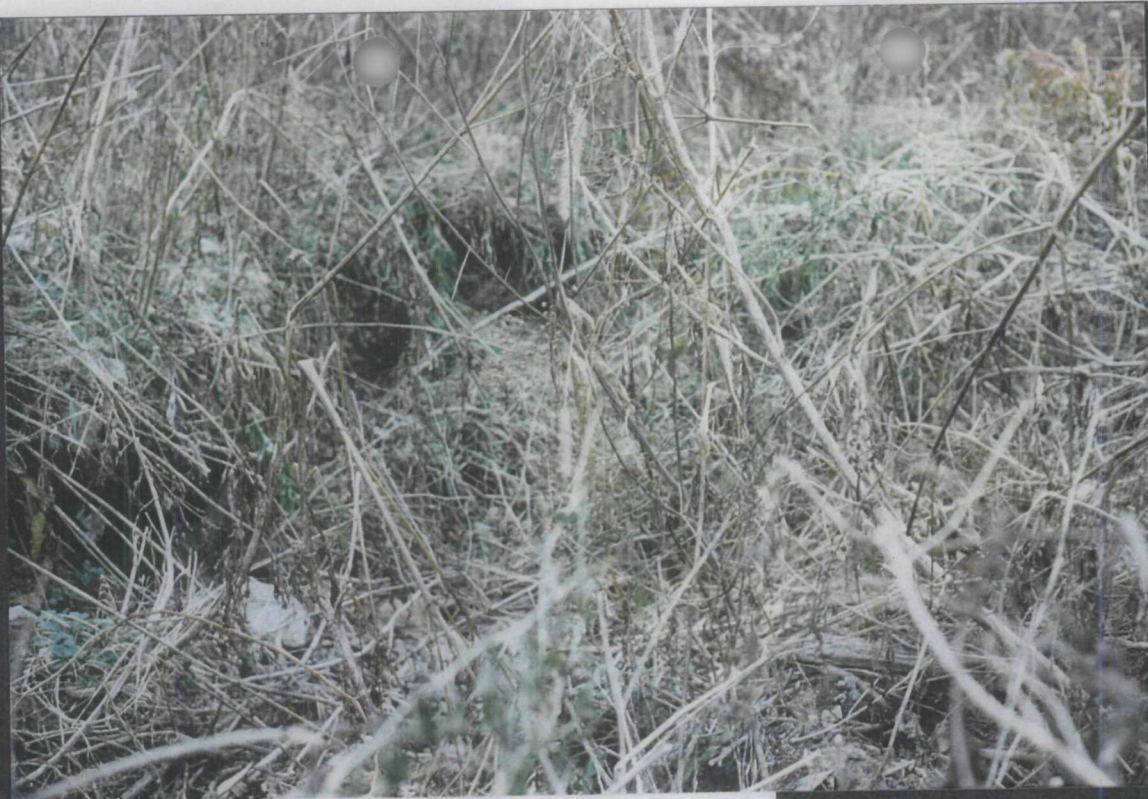
11-19-96 M. Mikulka  
 Gary Development Landfill  
 #15 -- View of ditch on E. Side of  
 property as it meanders towards  
 wetlands area on SE side of GDC.  
 See #13.

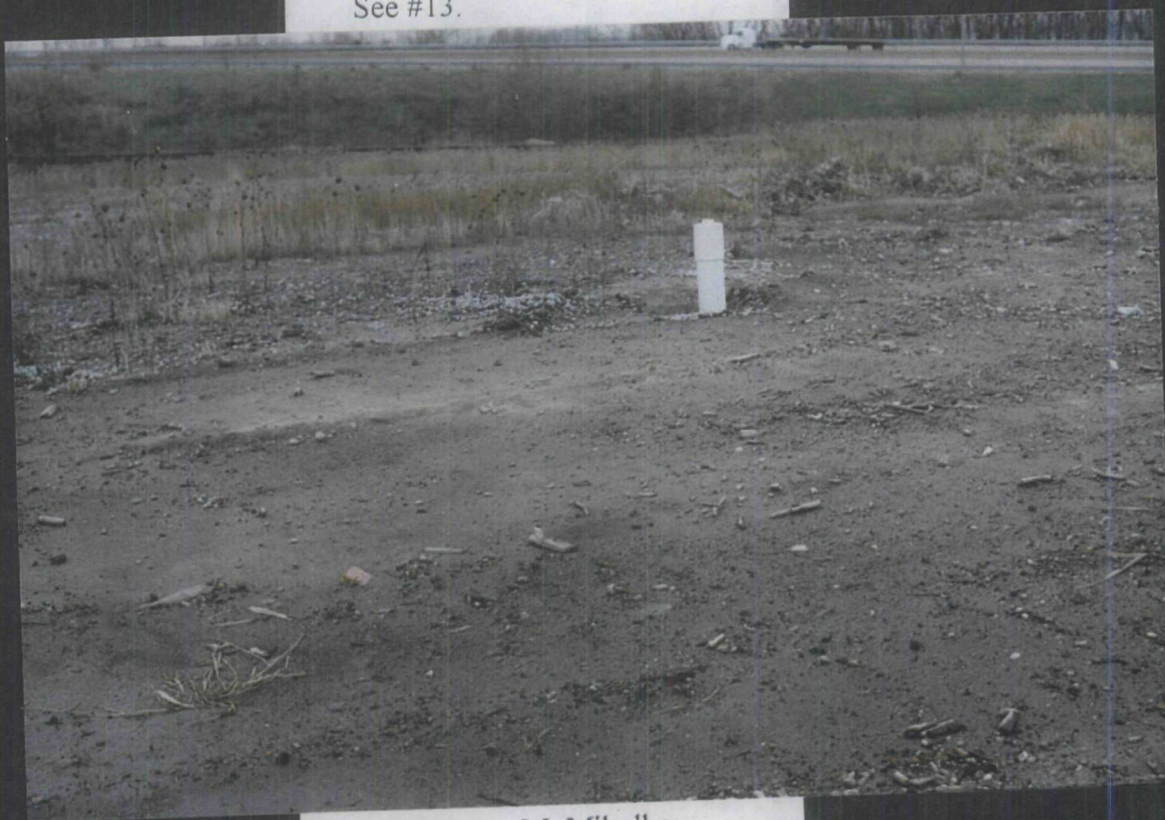
11-19-96 M. Mikulka  
 Gary Development Landfill  
 #16 -- gas recovery well (typical)  
 installed at GDC. Note lack of  
 vegetative cover on the landfill.

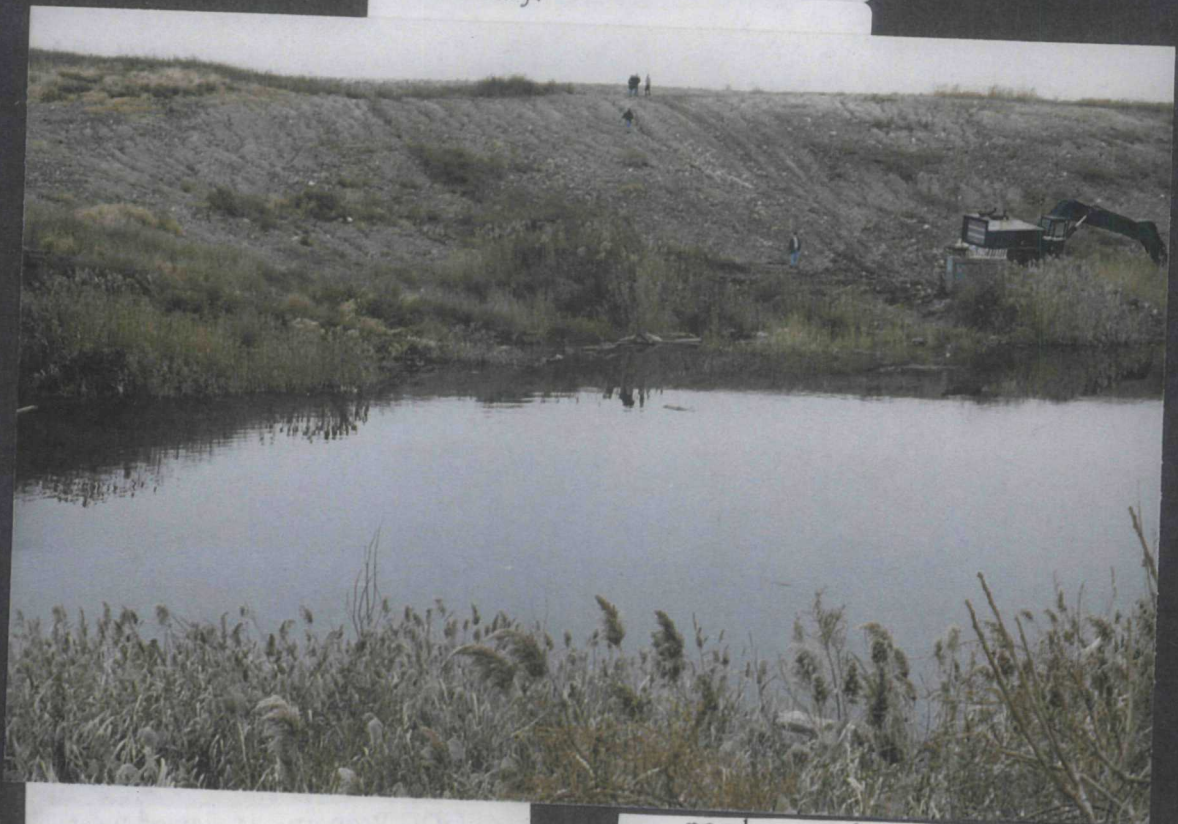
11-19-96 M. Mikulka  
Gary Development Landfill  
#18 -- View of central portion of  
leachate/storm water collection

pond on north side of Property, as  
viewed from north property  
boundary. Shows north face of  
landfill. Note lack of vegetative  
cover and rill erosion.

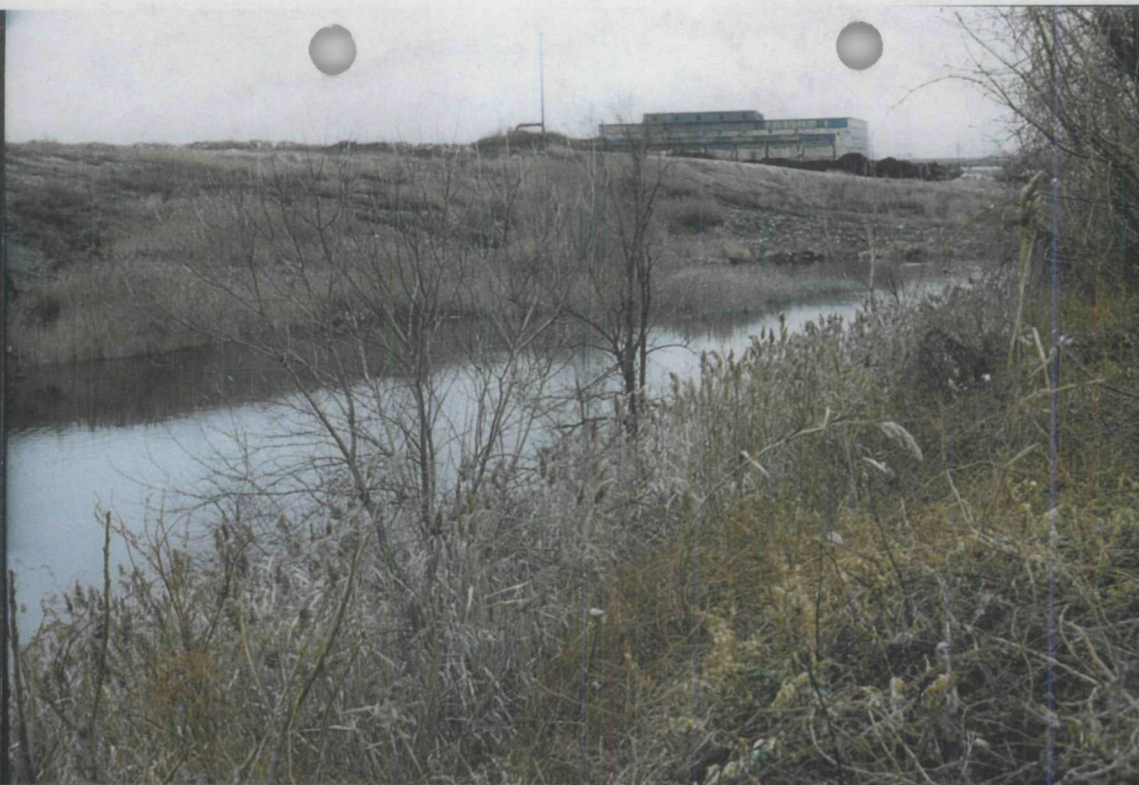
11-19-96 M. Mikulka  
Gary Development Landfill  
#19 -- View of western portion of  
leachate/storm water collection  
pond on north side of GDC

Property. Building in background  
is AMG Resources facility, which  
is due west of GDC site. At top of  
pond, demolition debris can be  
seen.

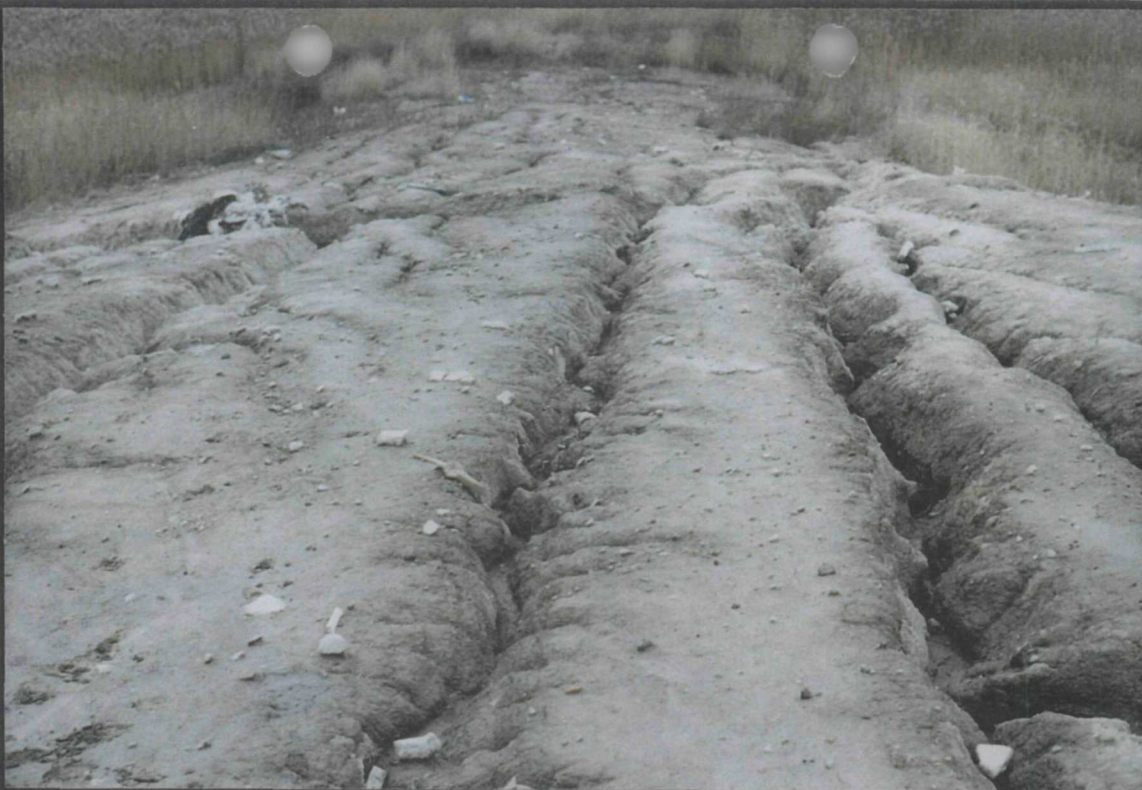
11-19-96 M. Mikulka  
Gary Development Landfill  
#21 -- View of western face of  
GDC landfill, from top of landfill  
and facing west. Note severe

erosion, cap material at toe of  
slope, and trash from landfill.

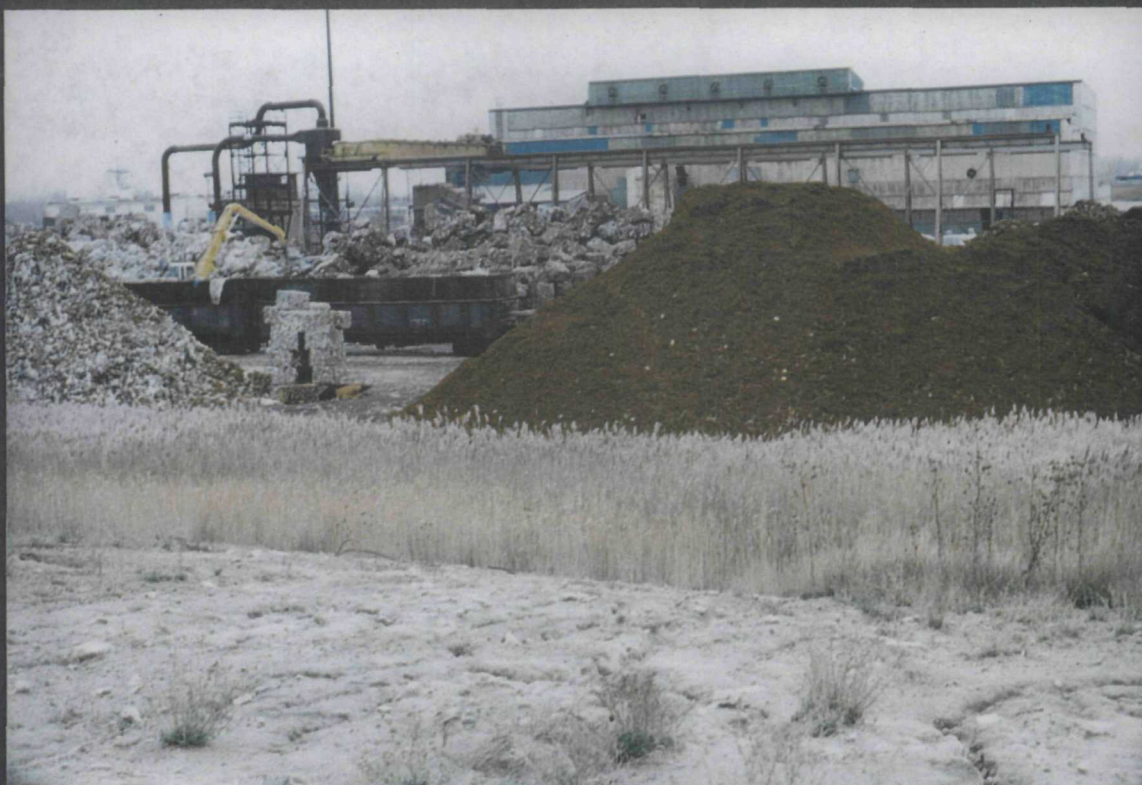
11-19-96 M. Mikulka  
Gary Development Landfill  
#22 -- View of AMG Resources  
facility as seen from W. Side of  
GDC Property. Note western face

of landfill in foreground, and  
depressed area at toe of slope,  
where storm water from western  
portion of landfill drains.

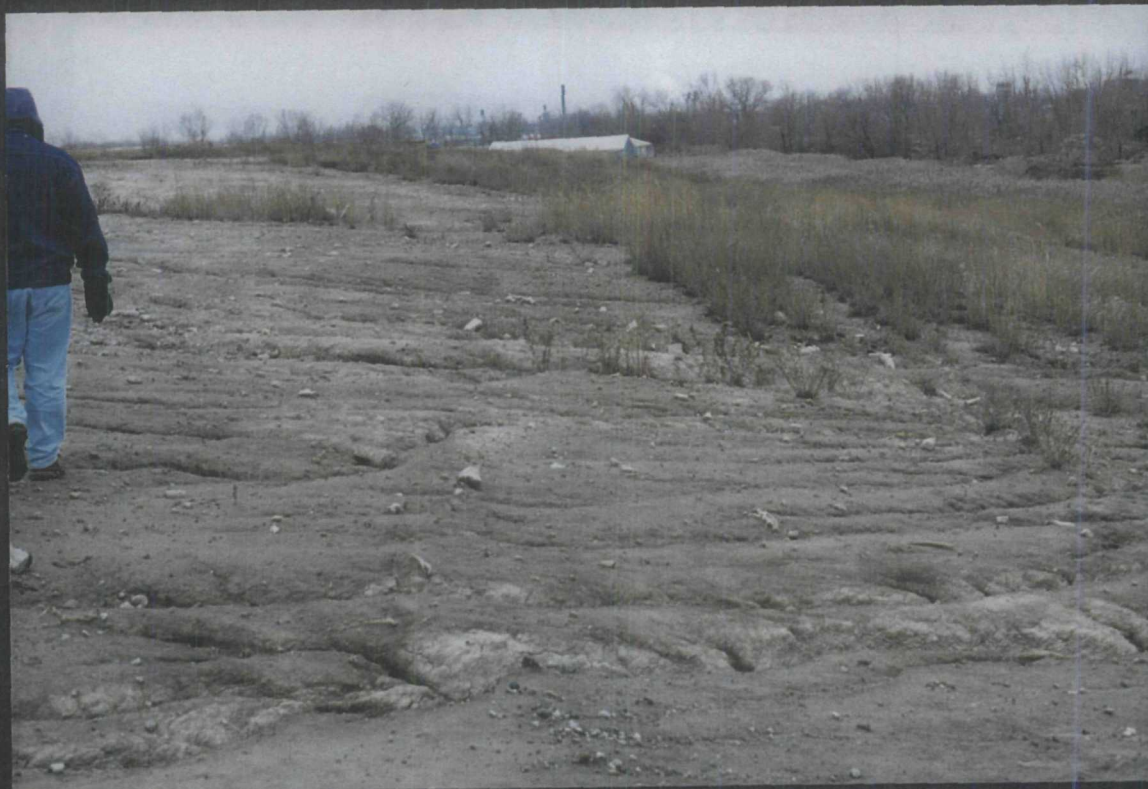
11-19-96 M. Mikulka  
Gary Development Landfill  
#24 -- View of western face of

GDC landfill as viewed from north  
to south. Note GDC offices in  
background. Note erosion  
problem along complete face, and  
lack of vegetative cover.

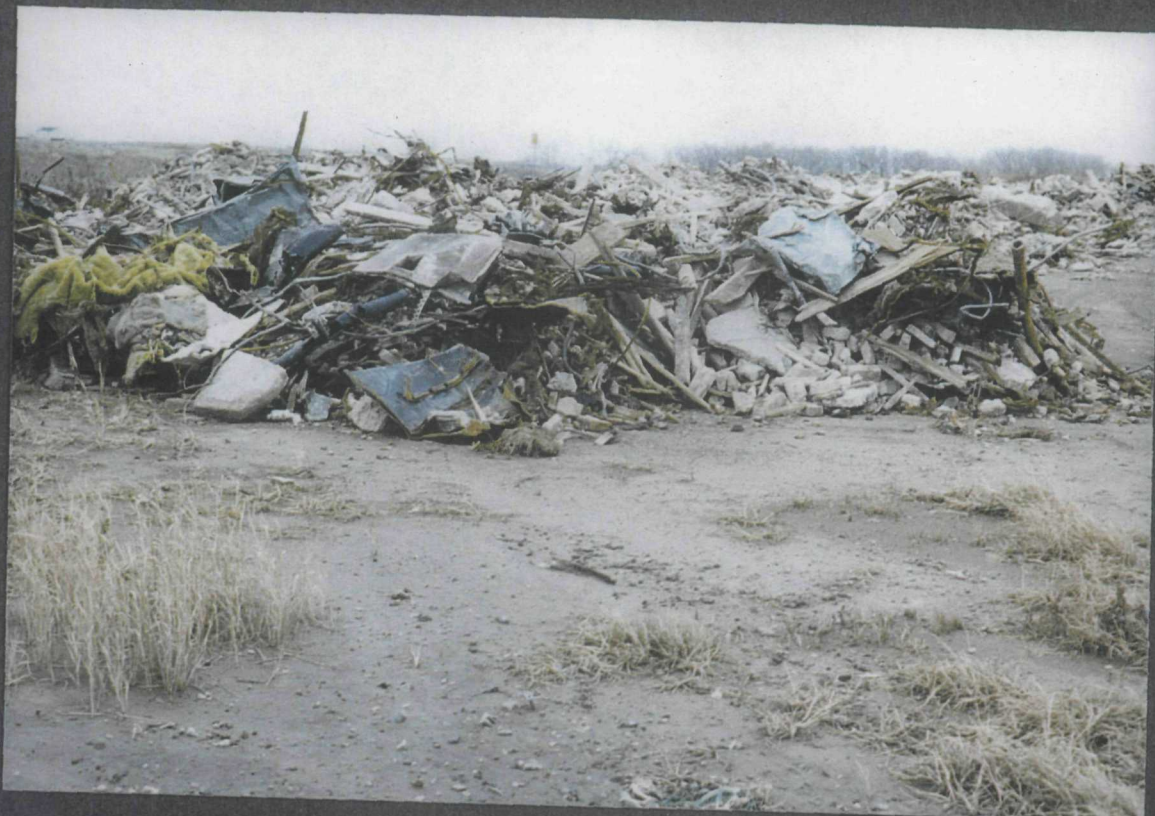
11-19-96      M. Mikulka  
Gary Development Landfill  
#24A -- Solid waste material  
(demolition debris) dumped at  
GDC landfill since closure of  
facility. This material is located at  
northwestern portion of the  
landfill, at top of slope adjacent to  
leachate/storm water collection  
pond. See also photo #19.
